## HISTORIC DAM – MODERN UPGRADE

Geoffrey M. Taylor, P.E.<sup>1</sup>

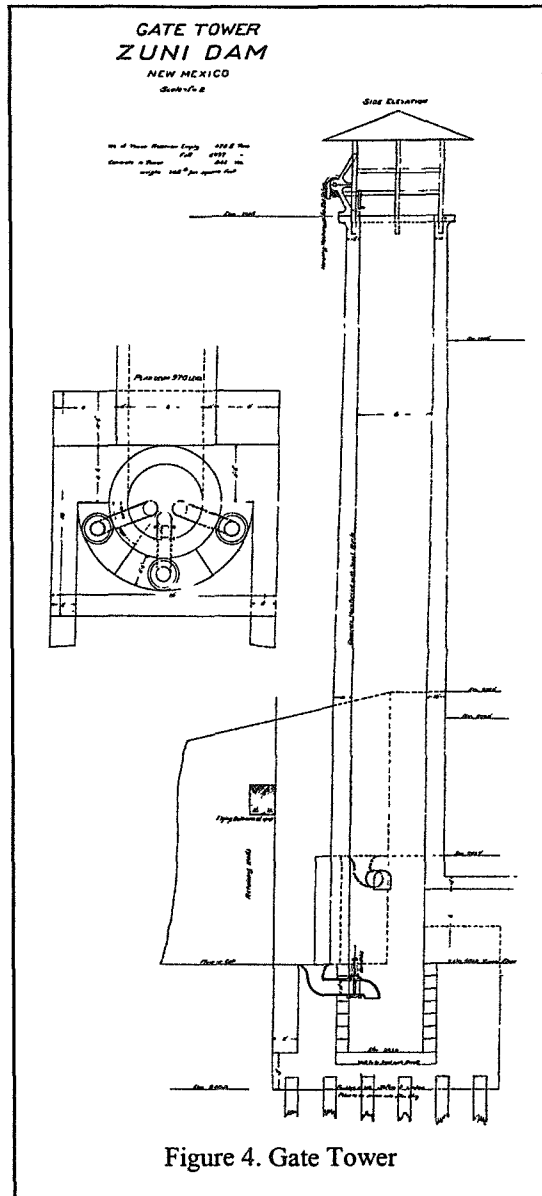
Figure 4. Gate Tower

trash rack. This low level gate was damaged and became inoperable in 1971, and a new gate was installed at a higher level, approximately the level of sediment in the reservoir. The low-level gate opening was sealed with concrete on the inside of the tower.

The 6-foot inside diameter tower was constructed of concrete reinforced with small railroad tracks and then-conventional, square reinforcing bars. The concrete was severely deteriorated due to freeze-thaw action, and there were several circumferential cracks in the structure.

The upper portion of the tower was removed and a circular steel liner was grouted into the remaining portion of the structure. The new steel liner extends up to the elevation of the top of the original tower, and a new reinforced concrete structure was built around the new liner. The new structure is designed to resist a pseudo-static seismic force of 0.33g, as well as water and sediment loads.

The original low level gate and concrete seal were removed and a new gate was installed. A trash rack structure with provisions for stop logs was incorporated with the gate replacement. The new, upper portion of the tower includes a second gate at the reservoir sediment level. Both gates are cast iron sluice

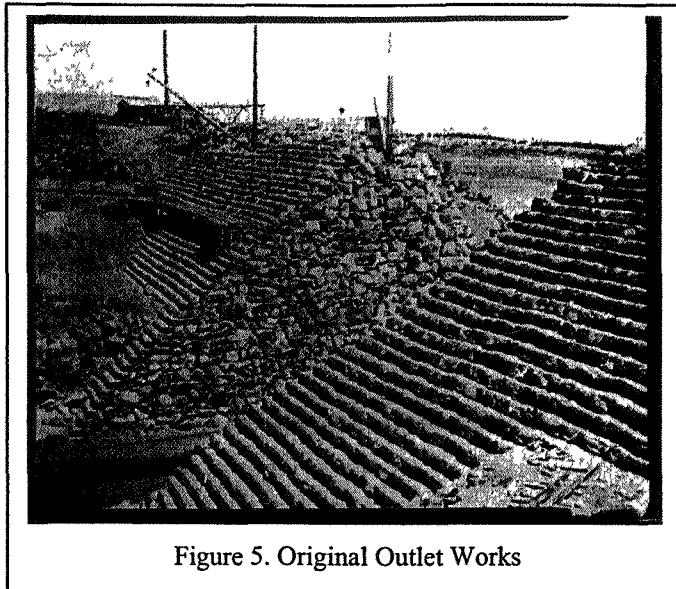
The outlet works conduit is a six-foot diameter, concrete lined, tunnel through the right abutment, below the overlying basalt. The concrete lining had longitudinal and circumferential cracks of up 3/8-inch wide and settlements of up to four inches in several places. In addition to the cracks, the joints between the lining segments had separated, up

to a half-inch, allowing water to enter the conduit. No reports were found on how the concrete lining was constructed. Observation of the tunnel and construction debris at the site indicate that it was cast in place, in annular segments about two feet long and about one foot thick. Form supports for the concrete segments were steel angles bent into a circular shape, and the forms were two-foot long boards, spanning between adjacent circular steel angle sets. There are no records or reports of high seepage at or near downstream end of the conduit. The small amount of seepage that was observed could as easily have been from springs in the right abutment as from reservoir seepage along the conduit. Whatever efforts had been made during the original construction to prevent seepage along the conduit appeared to be successful.

Figure 5. Original Outlet Works

A four-foot diameter steel liner, sized to meet reservoir drawdown requirements of 250 cfs and designed to resist all external loads without relying on the original concrete lining, was grouted in place and welded to the vertical steel liner in the intake tower. The liner extends 40 feet beyond the downstream end of the tunnel to a new terminal structure. A sand filter was placed around the steel pipe liner at the end of the tunnel to control any seepage that might occur along the new steel liner and the original concrete tunnel lining.
