## HISTORIC DAM – MODERN UPGRADE

Geoffrey M. Taylor, P.E.<sup>1</sup>

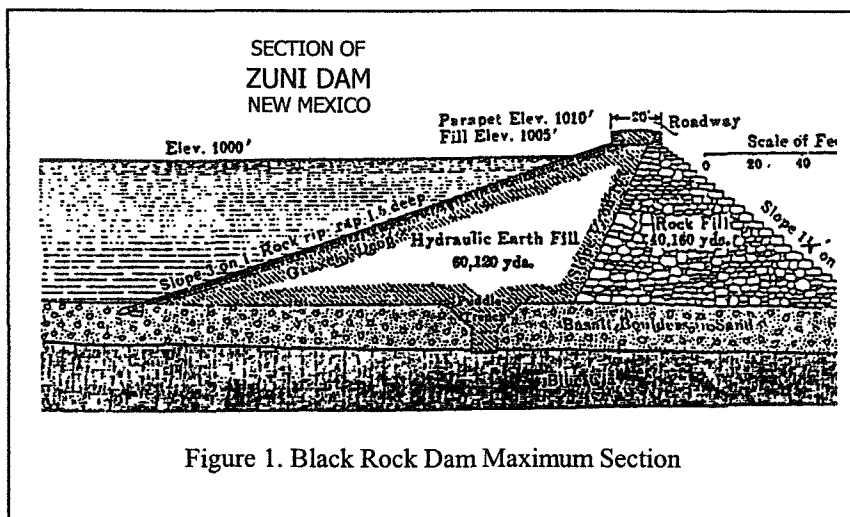
Figure 1. Black Rock Dam Maximum Section

section and an upstream hydraulic earthfill section. The dam is 80 feet high (structural height of 110 feet), and has a crest length of 780 feet. The original spillway was constructed by excavating a channel in the left abutment basalt, and lining the channel with concrete and masonry.

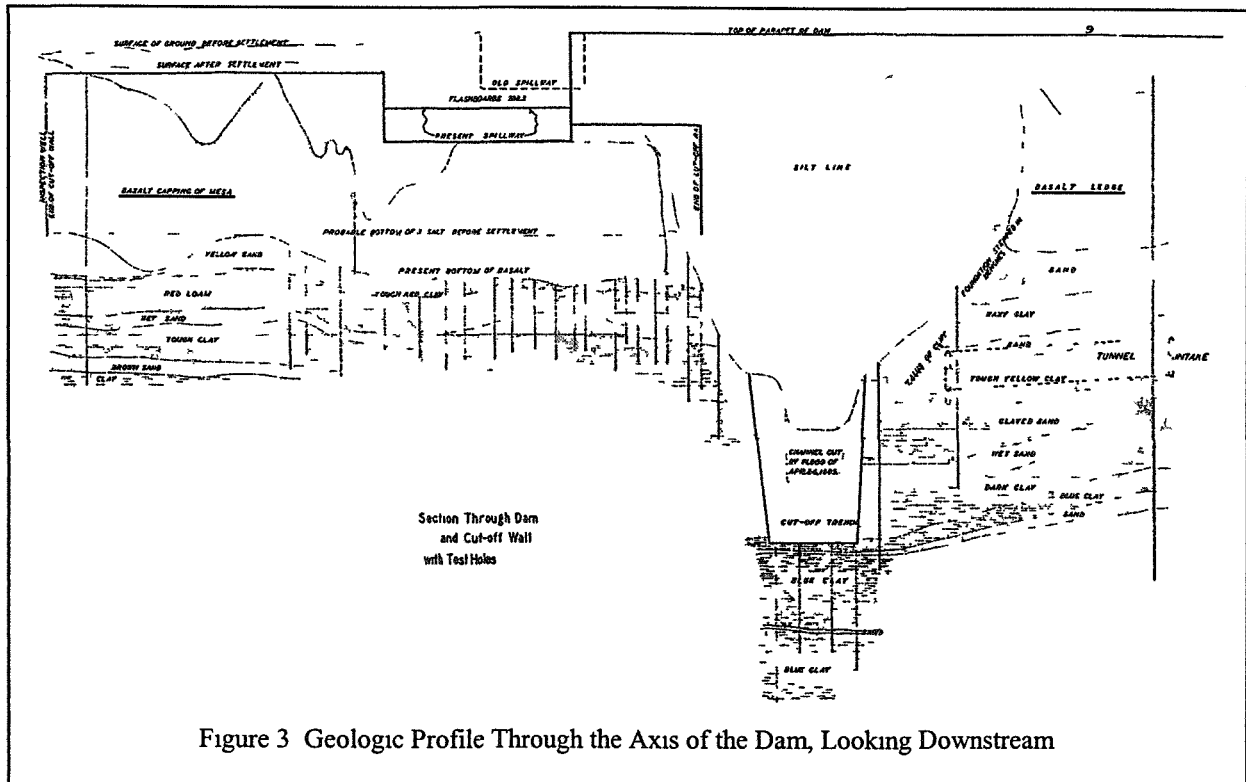
Figure 3 Geologic Profile Through the Axis of the Dam, Looking Downstream

During the first filling in 1909, reservoir water flowed through fractures in the basalt at rates up to 5000 cfs, eroding the underlying deposits, which resulted in settlements of up to 10 feet of the basalt blocks, partial collapse of the spillway structure and near failure of the left abutment of the dam. A new concrete and masonry spillway structure and a masonry and steel sheet pile cutoff wall were built in 1909-12. Exposed basalt was also blanketed with earth fill. Despite these attempts to limit flows through the basalt, the dam nearly failed from erosion in the left abutment in 1932 and again in 1936.

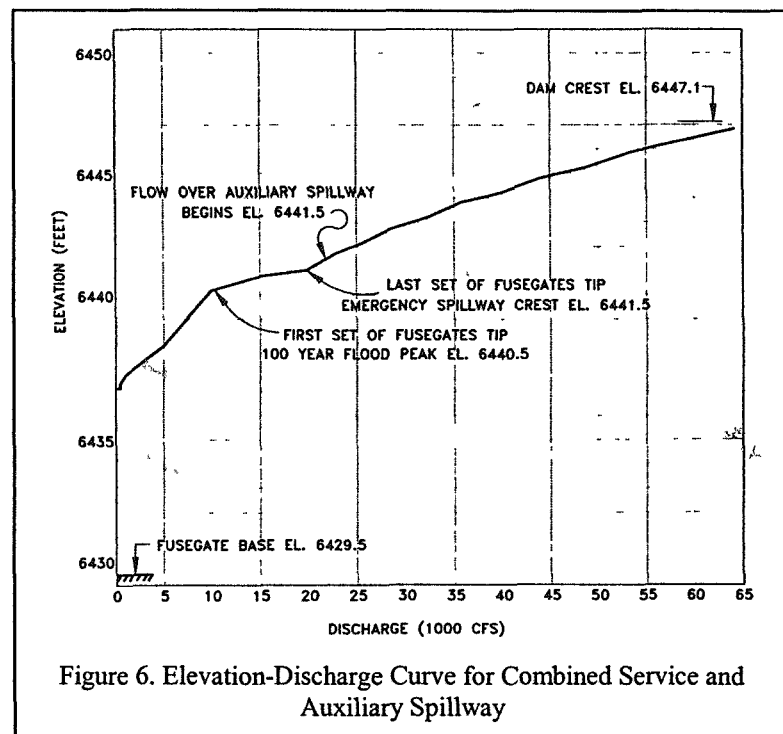
Figure 6. Elevation-Discharge Curve for Combined Service and Auxiliary Spillway

With this criteria, the auxiliary spillway was designed as an open cut on the left abutment, just left of the existing spillway. The auxiliary spillway consists of a channel excavated in earth and basalt, with a control section at the upstream end. The auxiliary spillway can pass 31,500 cfs with the reservoir elevation at the crest of the dam. The combined capacity of both the service spillway and auxiliary spillway is 63,500 cfs.

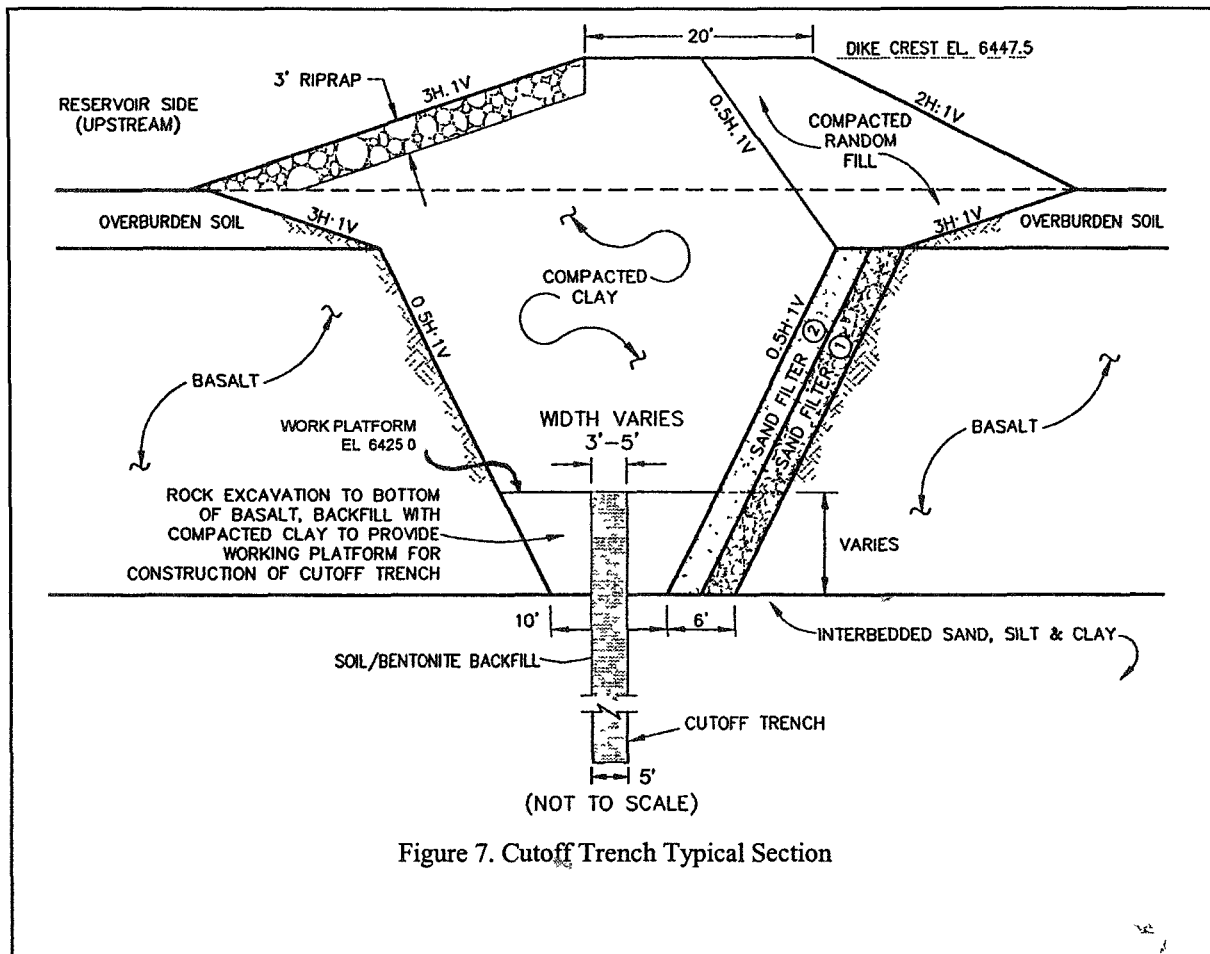
Figure 7. Cutoff Trench Typical Section

Once the cutoff trench was constructed, the remainder of the trenches in basalt were backfilled with clay and filter material. Because of expected settlement of the soil-bentonite material in the cutoff trench, which could potentially form a void below the clay backfill, the backfill was not placed until several months after completion of the slurry trench. Settlement measurements were taken of the cutoff trench backfill at seven locations along the trench during this period. Settlements were generally 0.8 to 1.2 feet at 180 days.

In order to construct the cutoff trench, trenches in each abutment had to be excavated through the basalt to expose the underlying soil. The trenches were designed to be as narrow as possible. The trenches were excavated by blasting, with side slopes of 0.5 to 1, and a nominal bottom width of 10 feet. Open fractures in the exposed downstream face of the basalt were manually filled with grout. The trenches were then backfilled with compacted clay, with filter material against the downstream face of the basalt, to a constant elevation, providing a work platform 20 feet wide for the slurry trench construction. The slurry trench was constructed to 75 feet below the work platform
